ENVIRONMENTAL ASSESSMENT FOR 8 CONSTRUCTION SITES TYNDALL AIR FORCE BASE, FLORIDA

DRAFT ENVIRONMENTAL ASSESSMENT

Environmental Assessment for 8 Construction Sites Tyndall Air Force Base, Florida

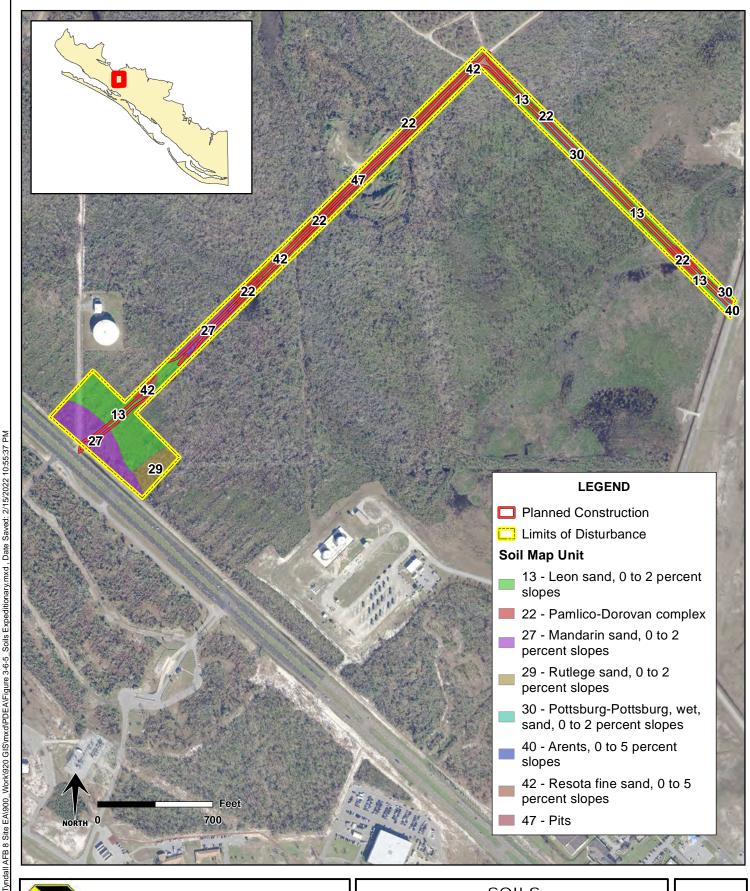
FIGURE 3.6-4

SOILS: **REPLACE WEG TOWER 1802**

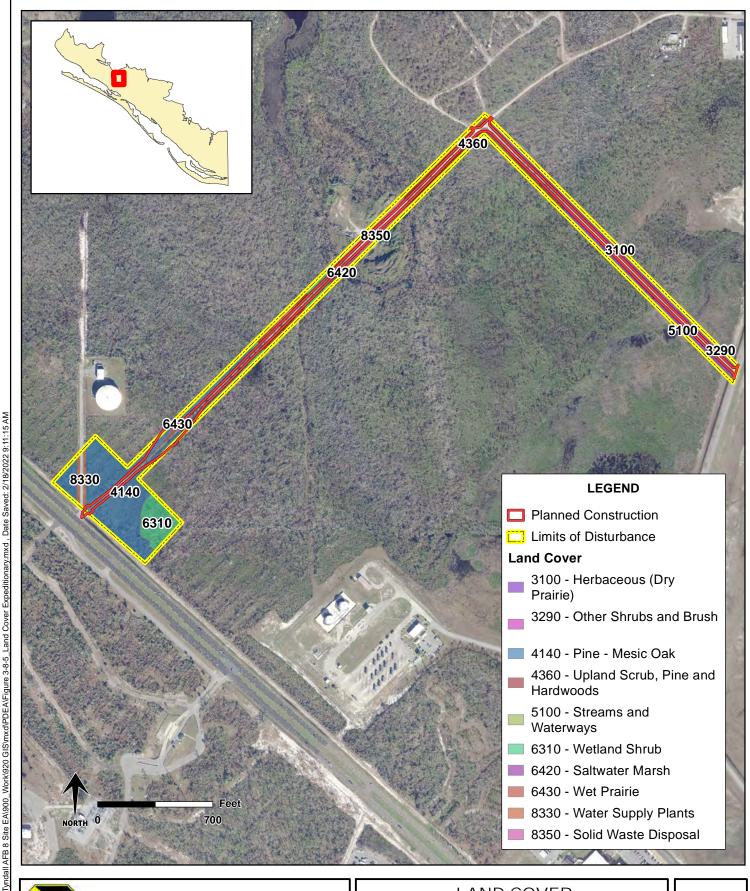
FIGURE 3.8-4

LAND COVER: **REPLACE WEG TOWER 1802**
